Blenheim Covered Bridge Replacement

Town of Blenheim, Schoharie County, NY

Brief Project Summary

Blenheim Covered Bridge 2019 ABCD Bridge Award

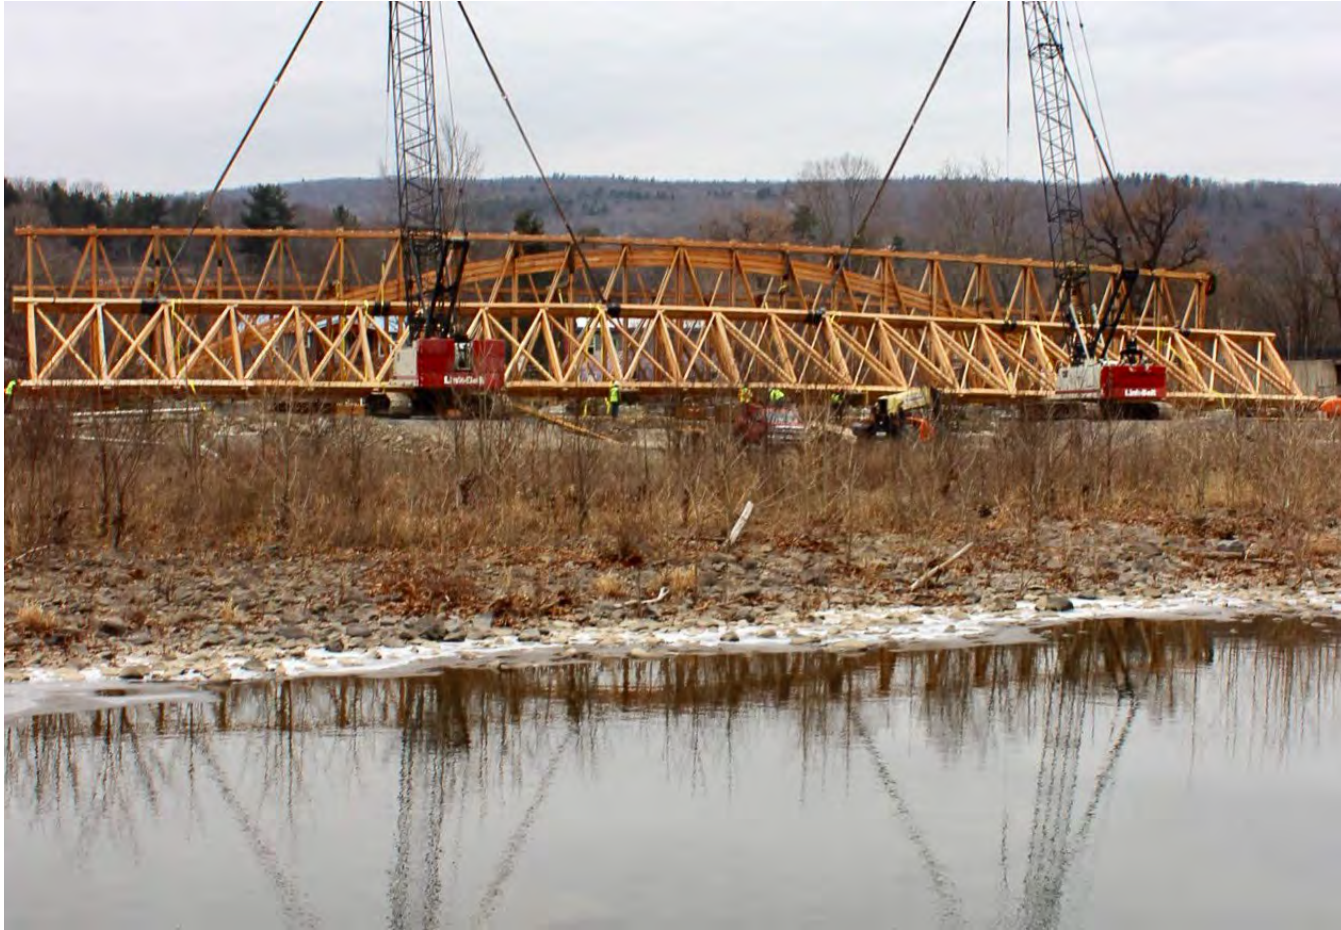
Economy Paving Co. employees two cranes to lift south truss

The prime contractor, Economy Paving Co. Inc., led the construction effort. The timber framer, 3G Construction of New Hampshire, constructed the bridge due to their three generations of experience in building and restoring covered bridges. The company used a combination of power tools and historically accurate hand tools, such as handsaws, mallets, and chisels dating back to the 1,800's to construct the bridge. The timber framer constructed the bridge on dry land approximately 400-ft from its proposed location. The bridge then was moved and raised. This was led by Jerry Matyiko of Expert House Movers, Inc., the same company hired to transport the Cape Hatteras Lighthouse to higher ground. The bridge was jacked, placed on powered dollies and rolled across a temporary bridge upstream of the abutments. It was then jacked up again, this time, higher than the newly constructed abutments. The contractor then used beams, rollers and hydraulic jacks to roll the bridge sideways (downstream) over the abutment. New jacks were installed on the abutments to lower it down until it rested on the new abutments.

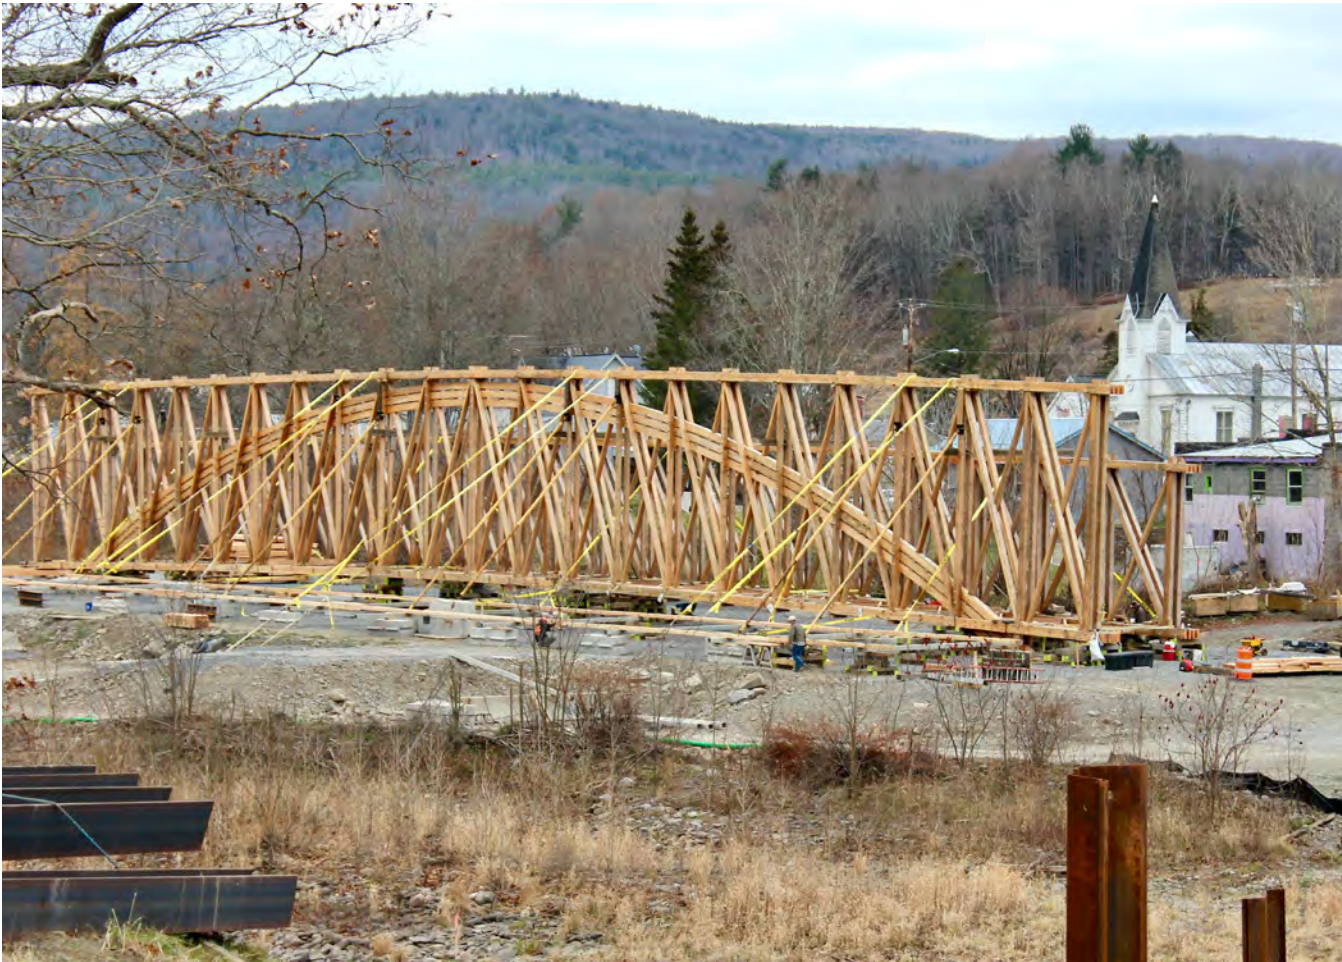
Economy Paving Co. employees two cranes to lift south truss

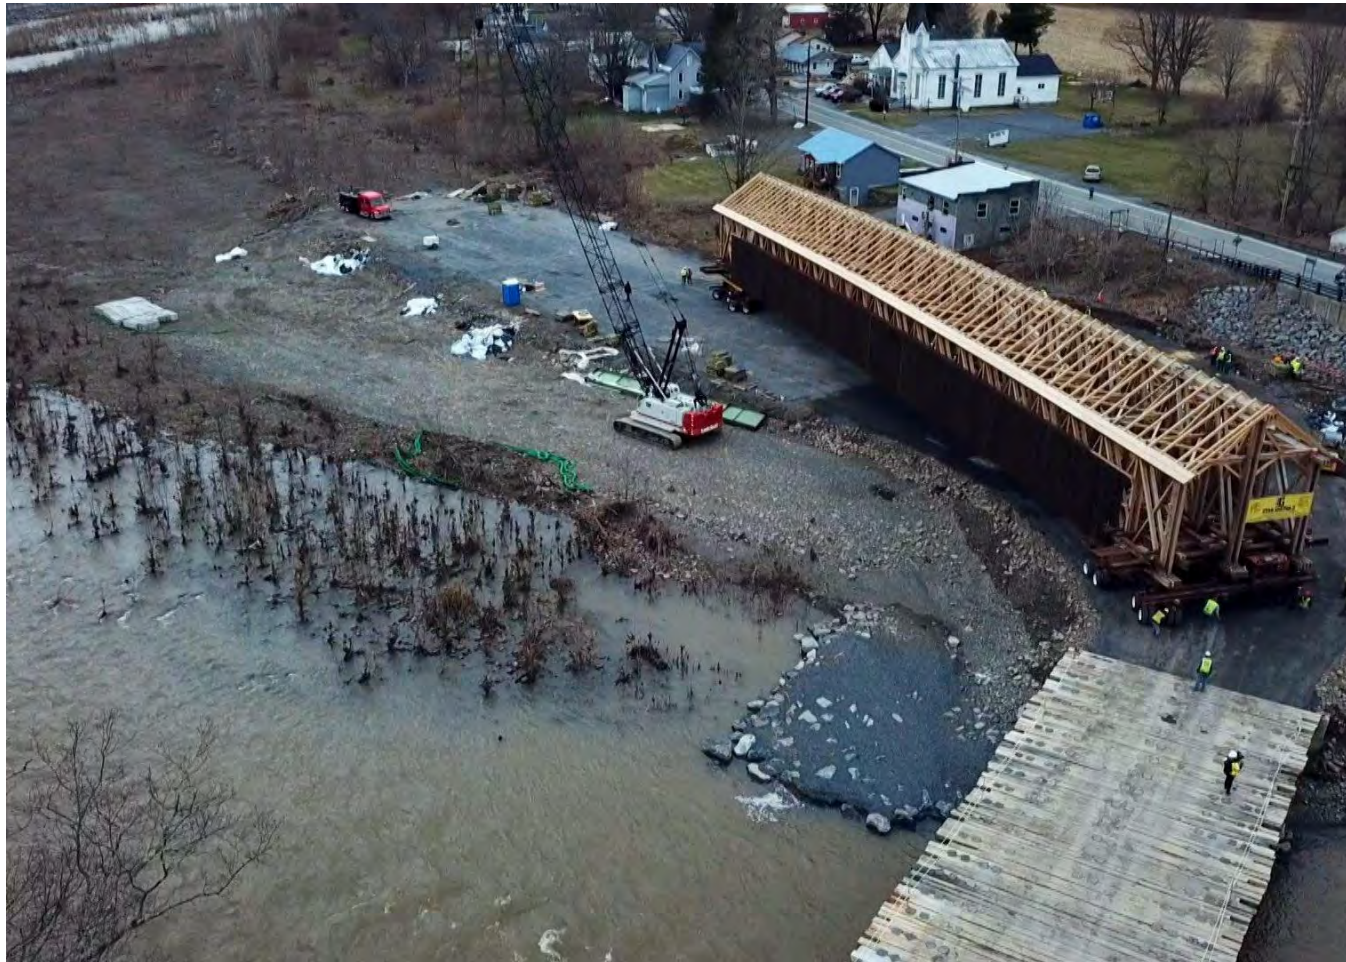
New covered bridge ready to slide onto temporary bridge

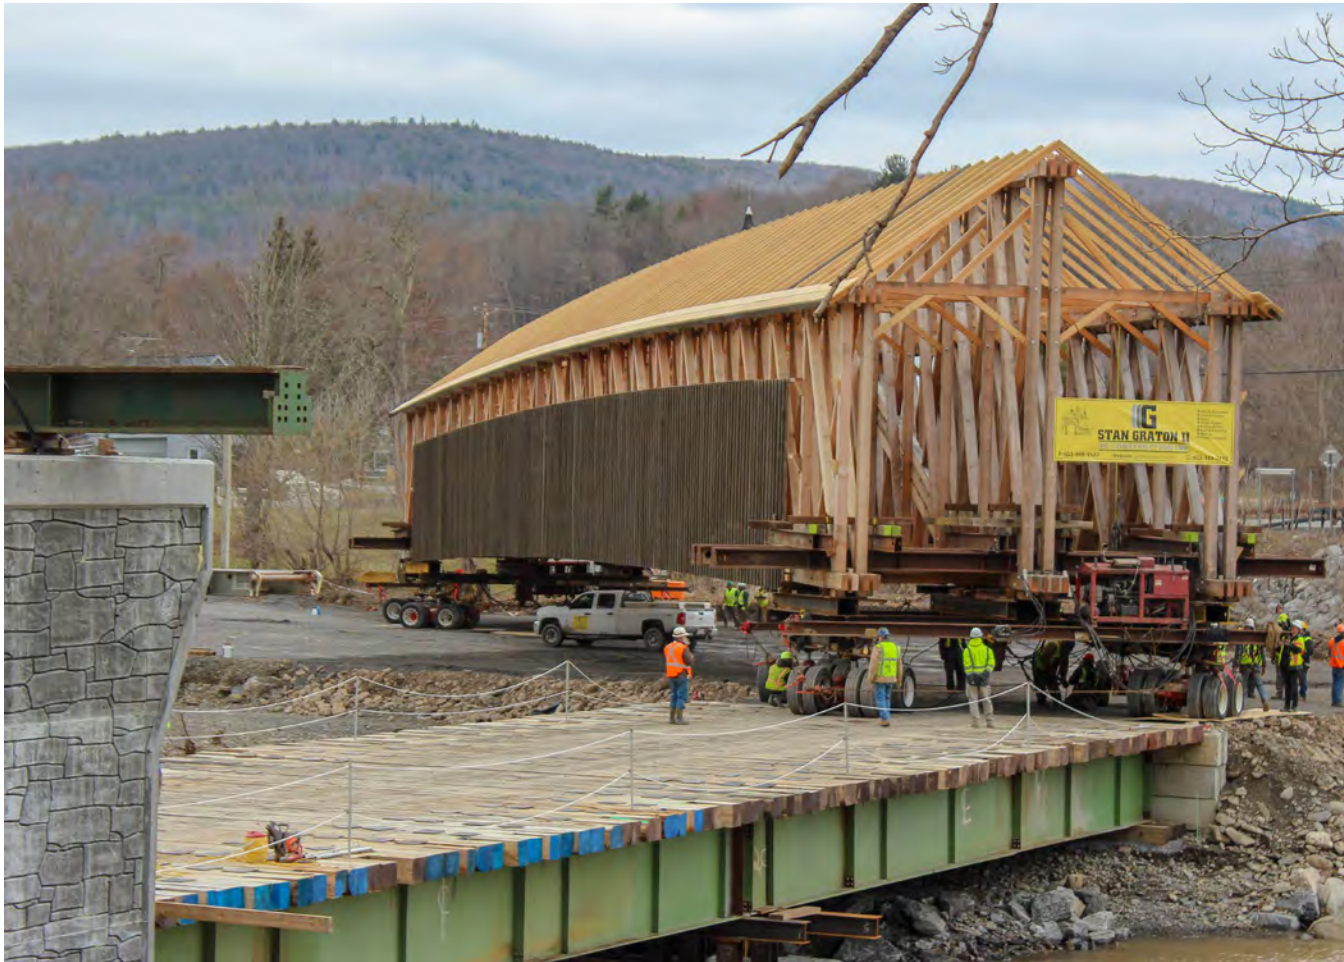
New covered bridge, turning the tight corner on to the onto temporary bridge

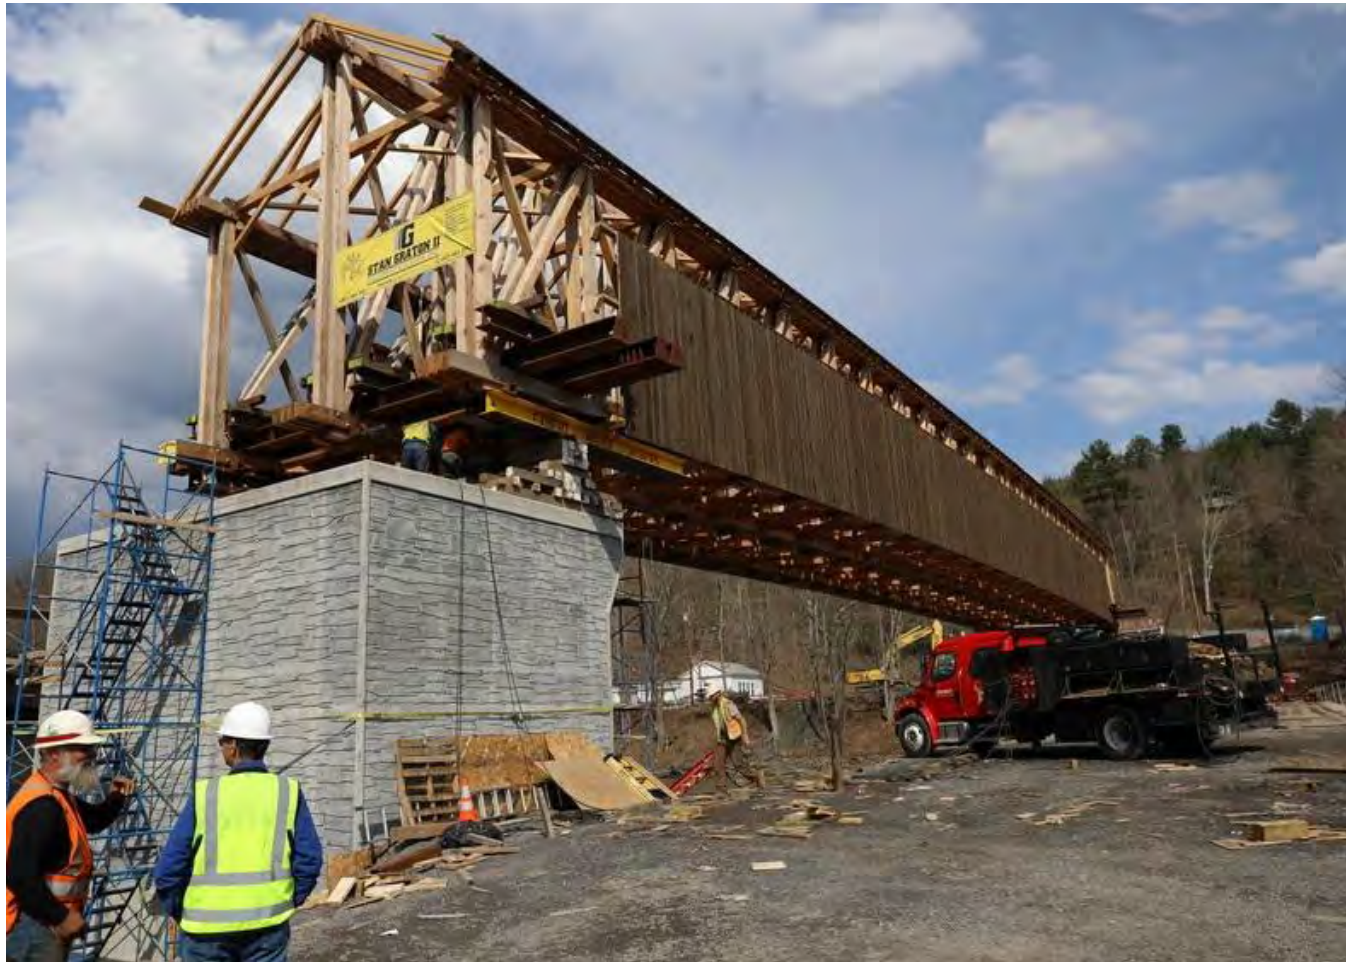
New covered bridge getting lowered onto the new abutments

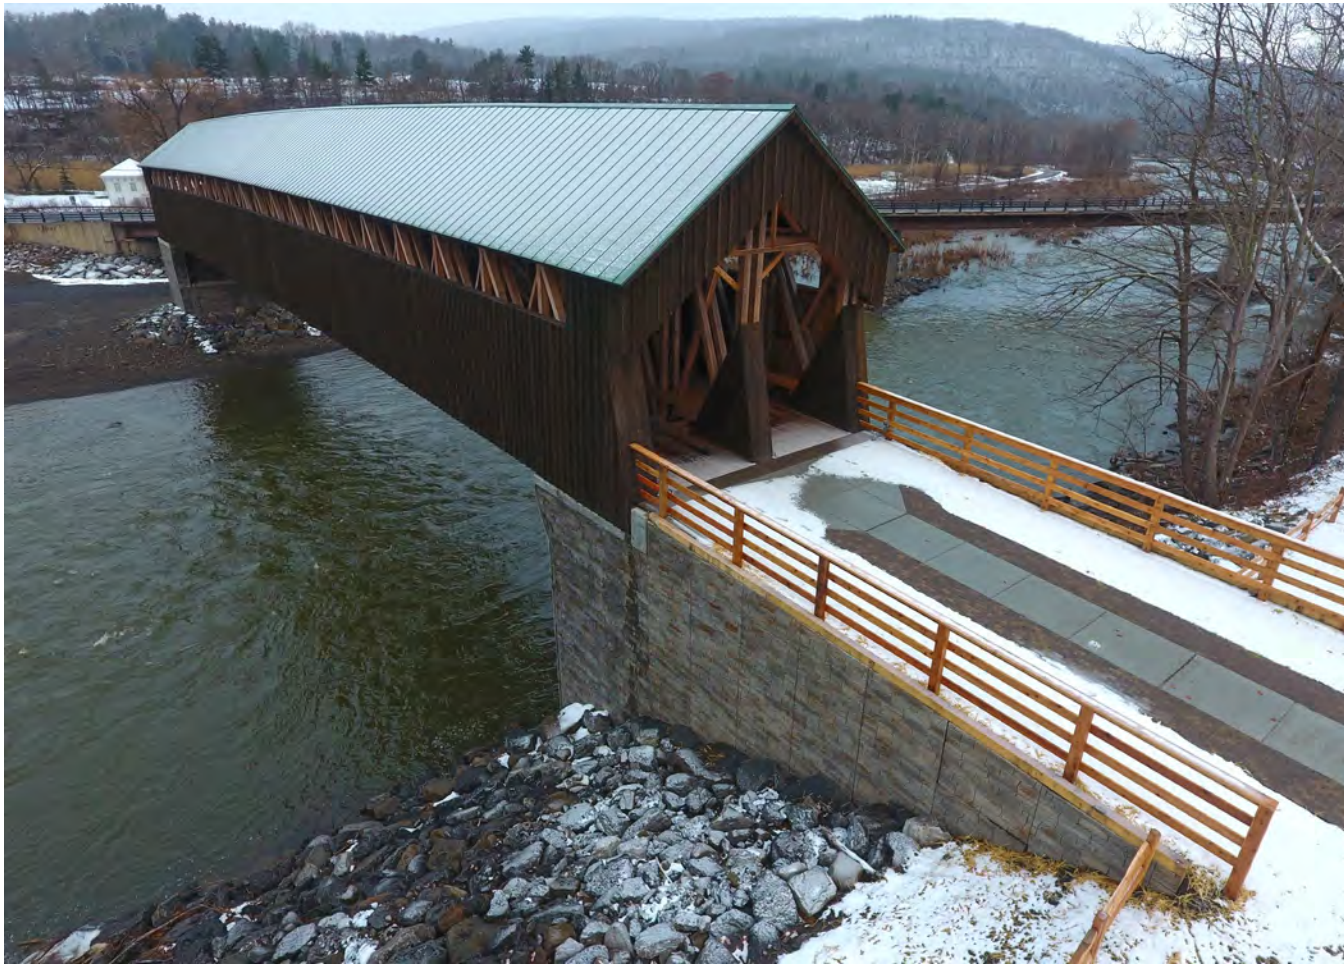
Completed Covered Bridge (East Side)

The new abutments are solid reinforced concrete, designed to look like the original abutments, which were laid-up stone. The new covered bridge was built out of Oregon Douglas Fir, with sawtooth joints being the backbone of each truss. Where possible, salvaged pieces of the original bridge were incorporated into the design of the new bridge to memorialize the historical structure, and to symbolize a community's strength to rise above the destruction of Irene.

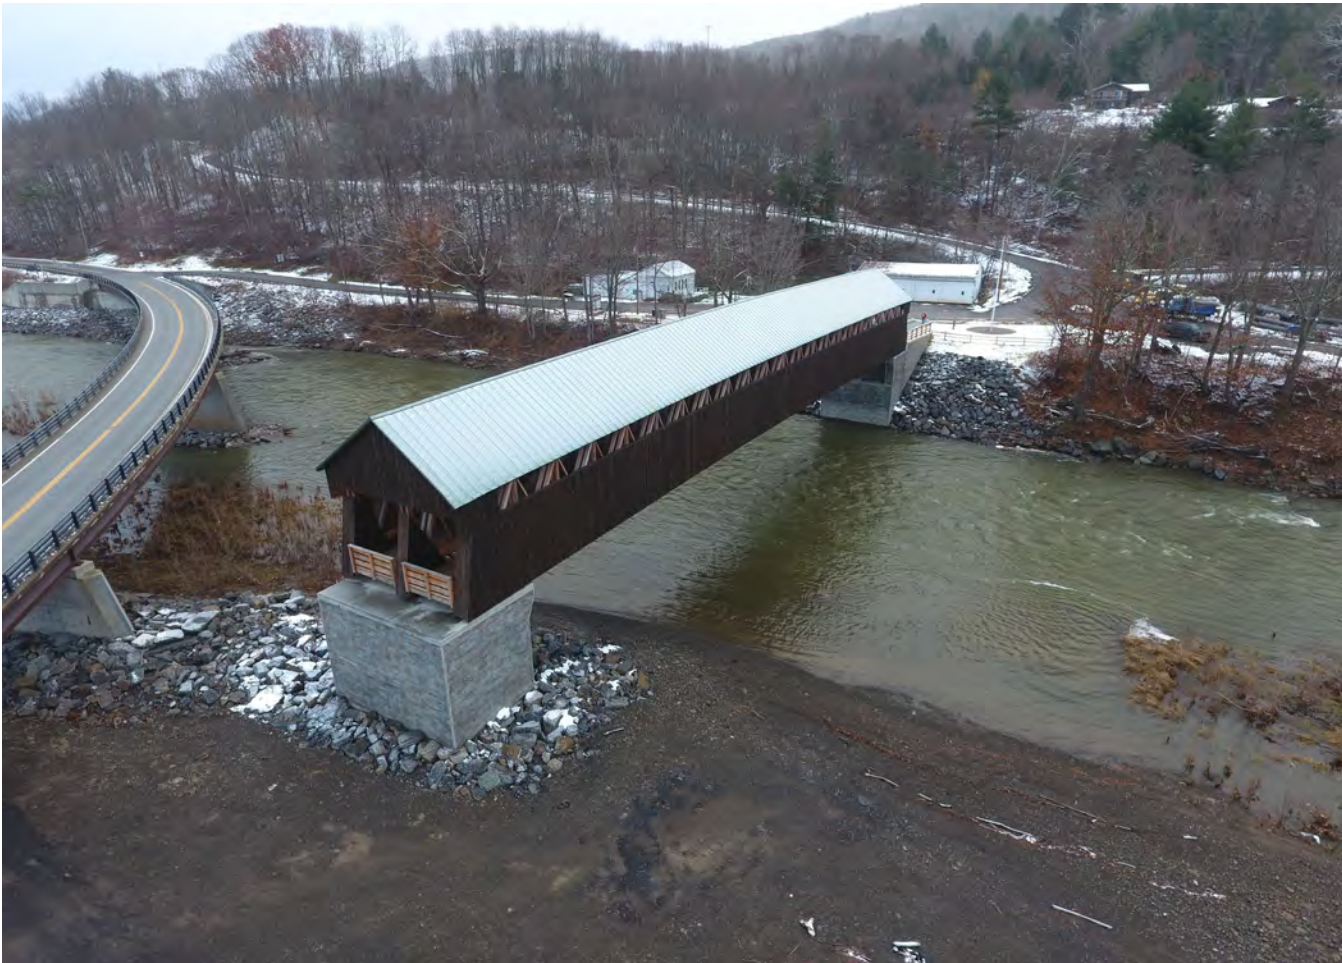
Completed Covered Bridge (West Side)
